# Aircraft Mishap Facts

## Second Half FY 84 Review

### Introduction

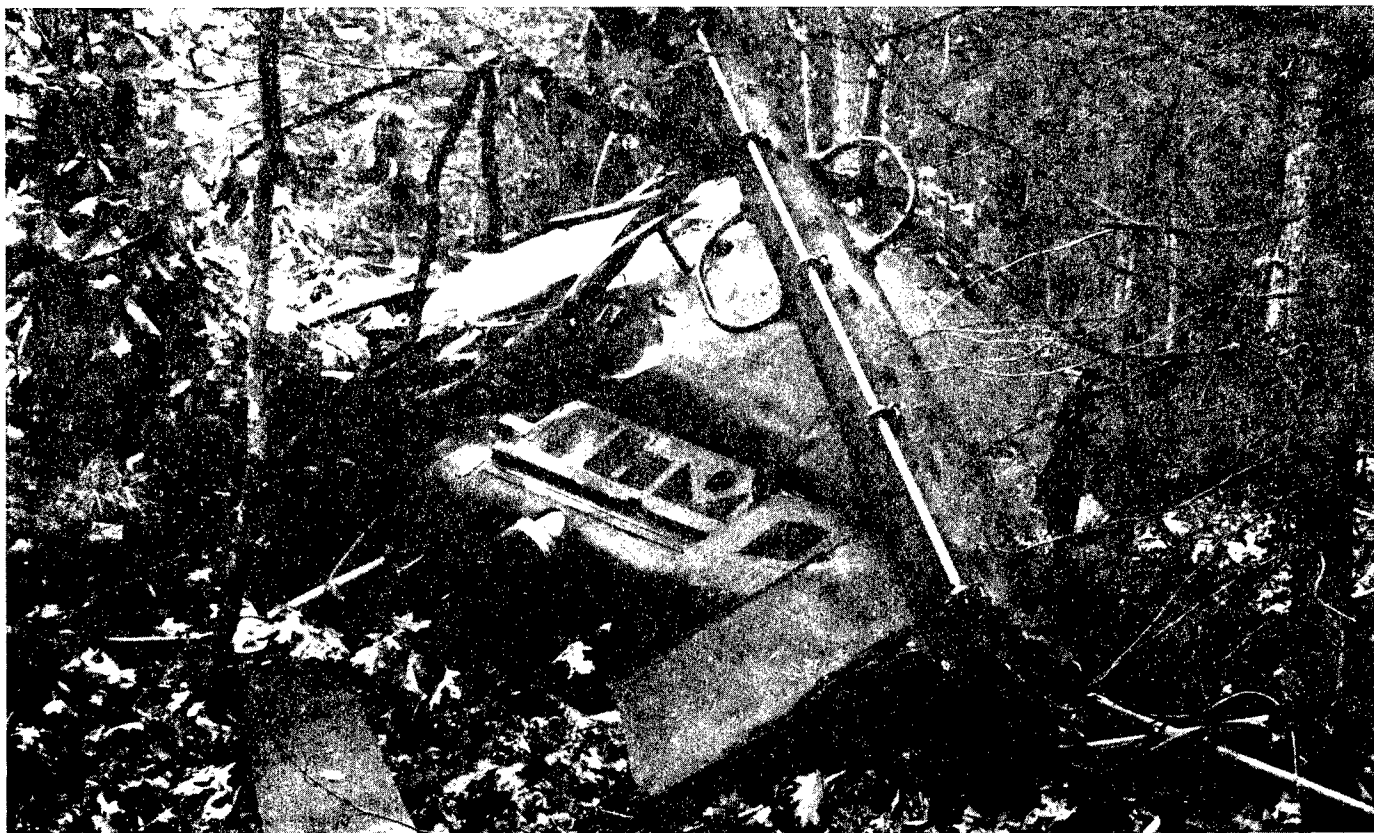
OH-58 descended into trees and crashed during training flight, killing the pilot and copilot.

**Cause:** It could not be determined why the crew allowed the aircraft to enter the trees. The crew may have crossed the hill at a low altitude and, seeing a tall tree to their front, made an evasive maneuver from which they could not recover at their low altitude.

**DA level:** Provide cockpit voice recorders and flight data recorders for Army aircraft.

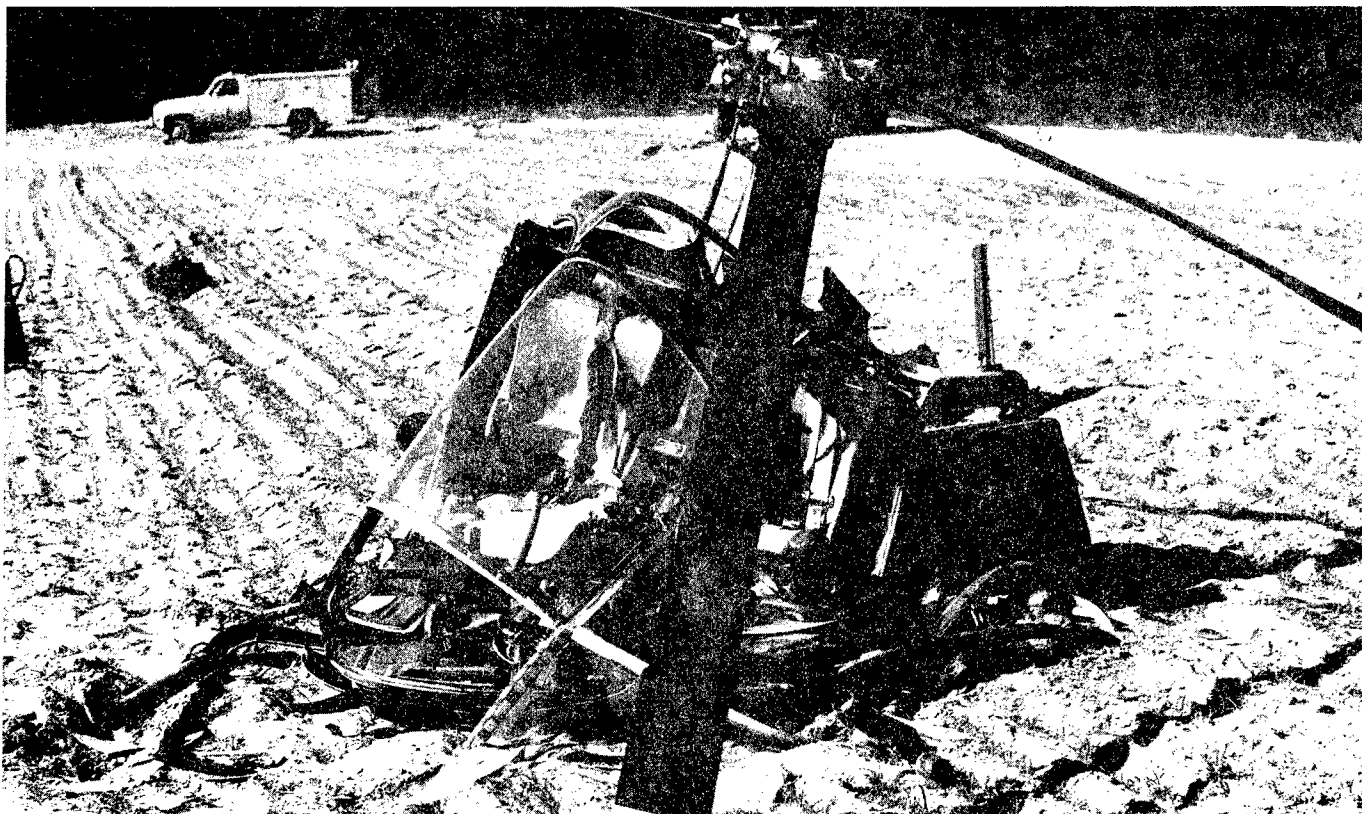
Tail rotor effectiveness was lost when an object hit the tail rotor blade of this TH-55. The student pilot did not follow correct emergency procedures and aircraft crashed.

**Cause:** When the object hit the tail rotor, the student pilot allowed cruise airspeed to fall below that required to streamline the aircraft and did not follow dash 10 emergency procedures.

**Unit level:** Brief all personnel on the importance of a thorough preflight, noting all loose or excess items which may produce damage if dislodged during flight operations. Stress the importance of accurate assessment of tail rotor malfunctions. Ensure all students are knowledgeable and capable of handling all emergencies in the TH-55 before conducting solo flights.

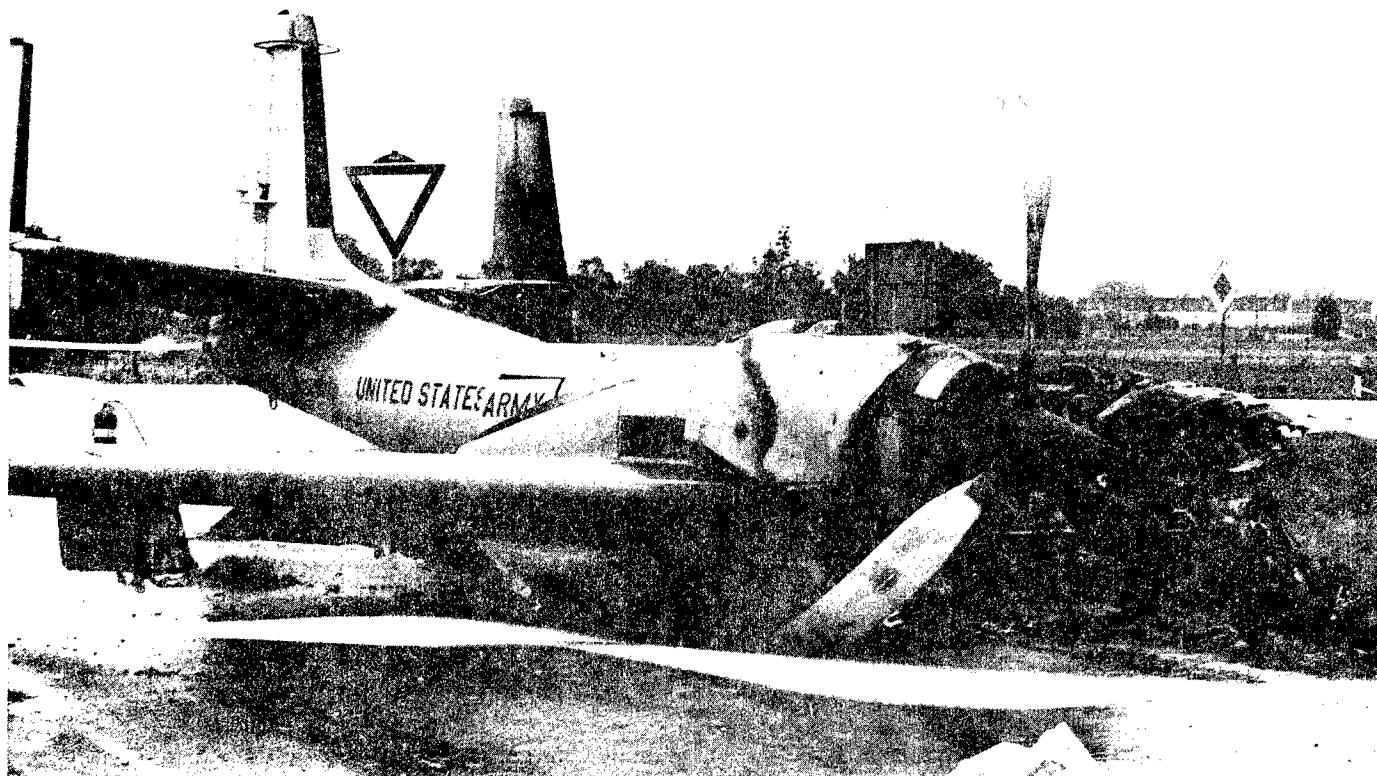
This Mohawk hit a flock of seagulls during takeoff. The pilot and technical observer ejected when the No. 1 engine quit.

**Cause:** The tower operator did not give the pilot a complete bird advisory, which should have included the estimated number of birds. The pilot did not ask about the number of birds because he thought they were "spooked" and would be out of the way during the takeoff.

**Unit level:** Emphasize to air traffic controllers the importance of issuing complete advisories in accordance with the Air Traffic Control Handbook in order to provide pilots with the most complete information available concerning the advisory/condition. Emphasize to aviators the importance of ensuring that when they are issued an advisory that may affect safe aircraft operation they either receive complete information or obtain appropriate information concerning the advisory/condition.

**Higher level:** Continue to take action to eliminate/reduce the potentially hazardous concentrations of birds from the airfield runway environment.
